MITCHELL FIELD WATER TOWER ASSESSMENT

Report of Findings

230515.00
Town of Harpswell, ME
March 2017

Mitchell Field Navy Facility Tank 100,000 Gallon Elevated Tank Condition Assessment Report

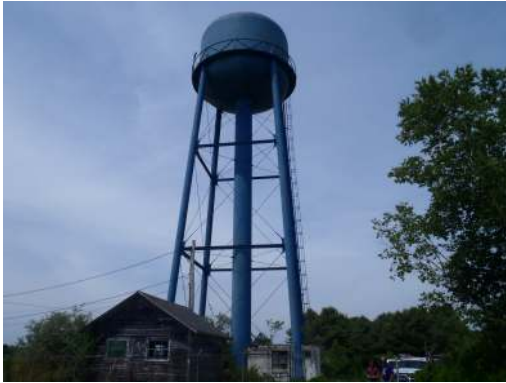
Overall view of the 100KG Mitchell Field elevated tank.

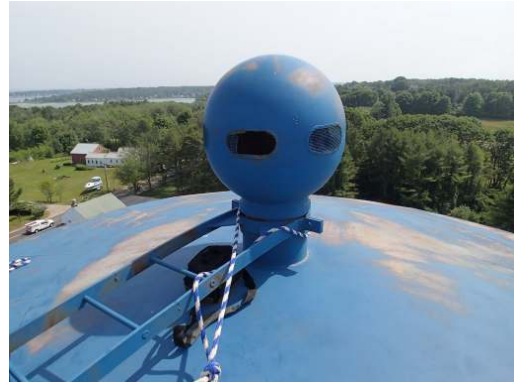
Roof finial ball has six 9"x4" oval vent screens, two of which have large holes.

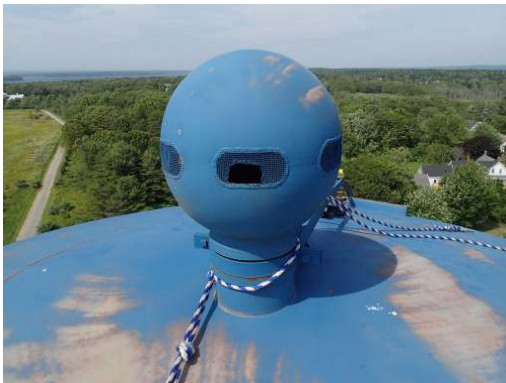
Showing a hole in the finial ball screen.

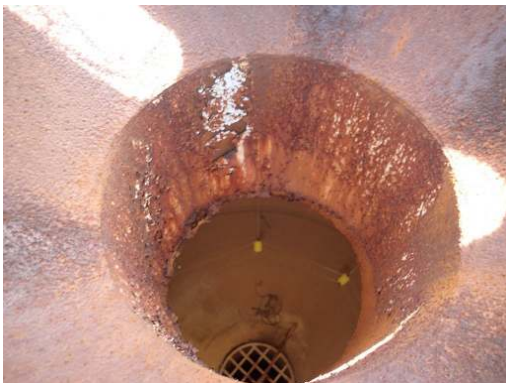
Showing corrosion on the interior of the finial ball which is open to the tank interior

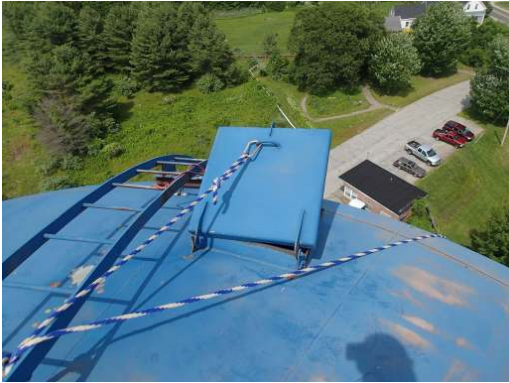
The hinges on the single 24"x24" hatch cover are broken

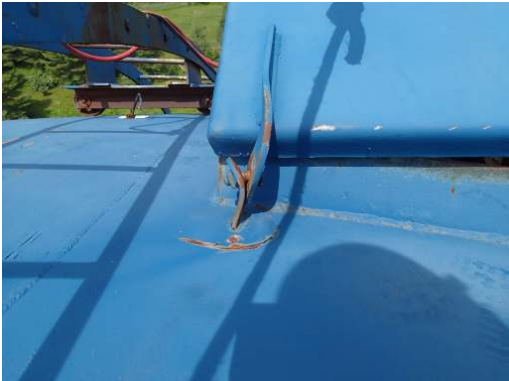
The second hinge is bent and twisted

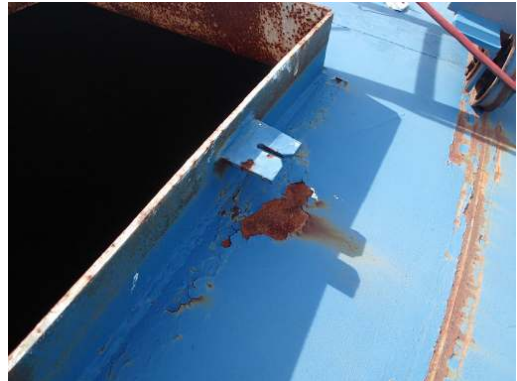
Showing a lock hasp present on the hatch neck but there was no lock

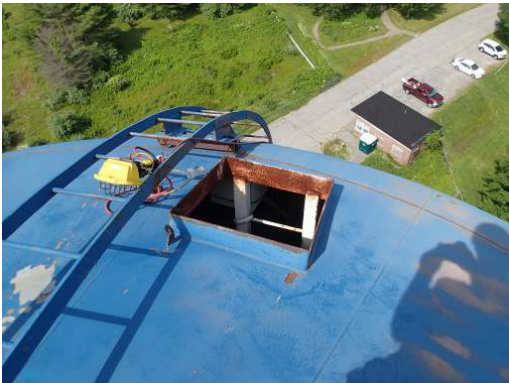
The hatch cover was removed for safety reasons due to poor structural integrity of the hinges

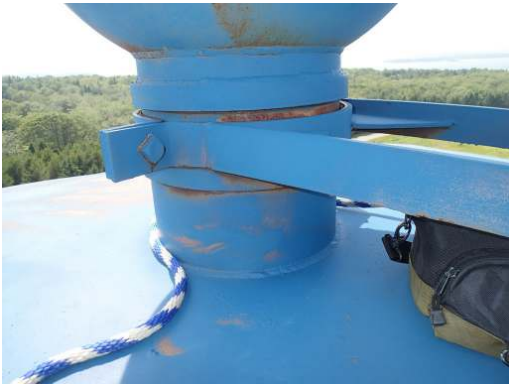
The revolving roof ladder connection bracket to the finial ball neck appears in sound condition but there is corrosion on the neck surfaces

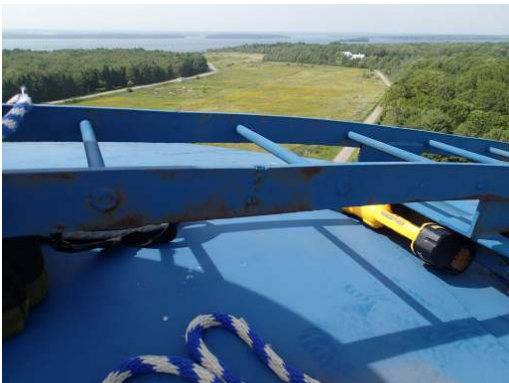
Showing corrosion of the roof ladder side rails.

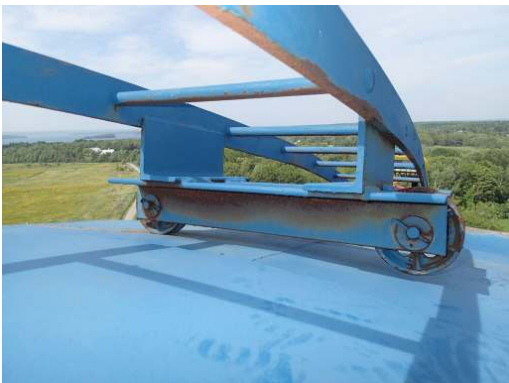
Shows medium grade corrosion on the underside of the ladder and wheel assembly.

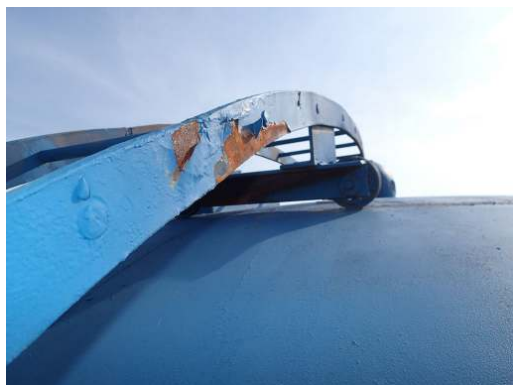
Shows medium grade corrosion where the coating has delaminated from the roof ladder siderails

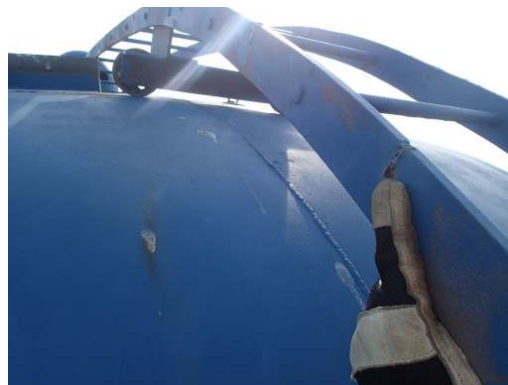
Showing a notch in the roof ladder side rail to allow for proper fit to curvature of the roof

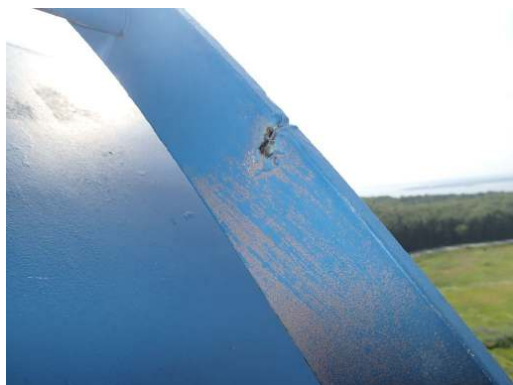
Showing a notch in the roof ladder side rail to allow for proper fit to curvature of the roof

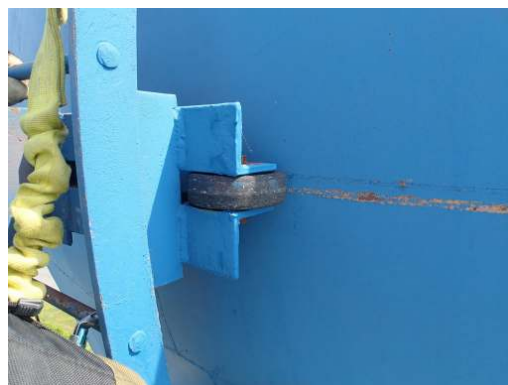
Shows abrasion damage on shell coating from the revolving ladder

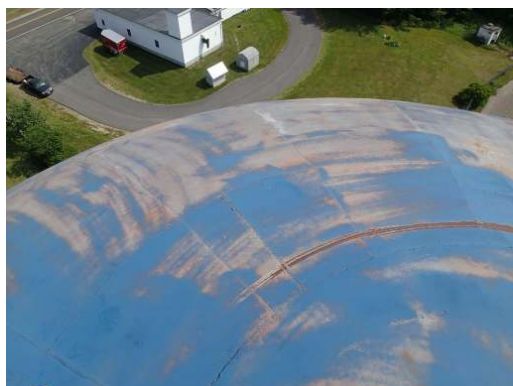
The exterior roof is in fair to poor condition with heavy weathering revealing the underlying coatings.

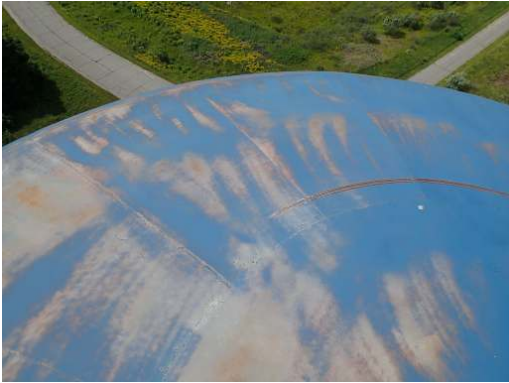
Light rust and severe weathering was observed throughout the roof plates

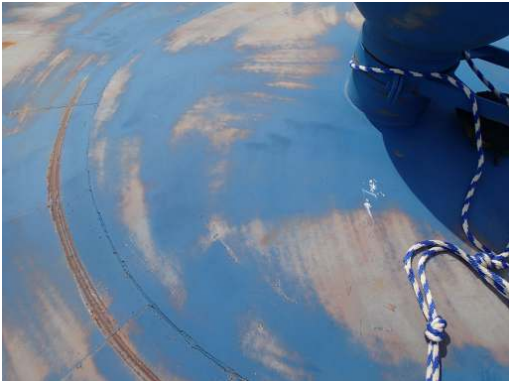
Showing weathering and abrasion damage along the center roof area

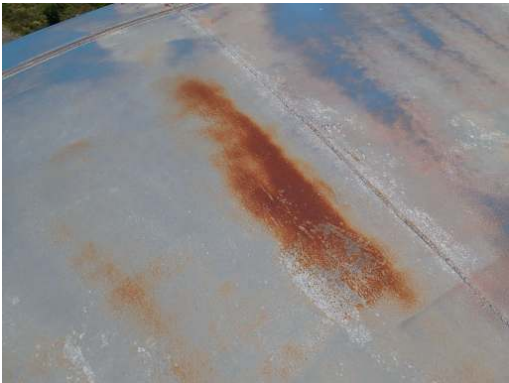
Shows light rust breaking through the coatings on the roof

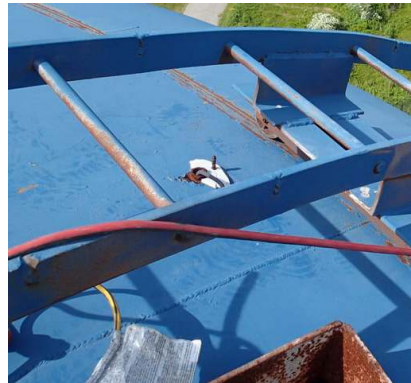
There is an open hole in the roof for wiring that should be sealed if the tank is returned to service

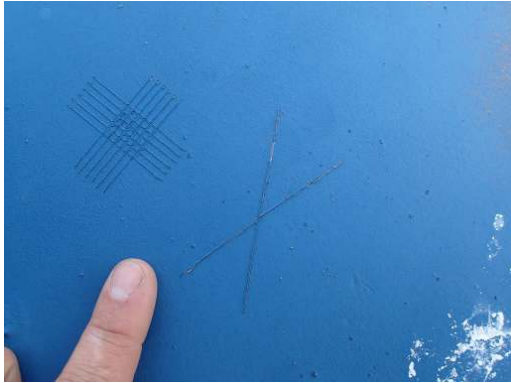
Shows adhesion testing on roof surfaces indicating generally sound interfacial adhesion

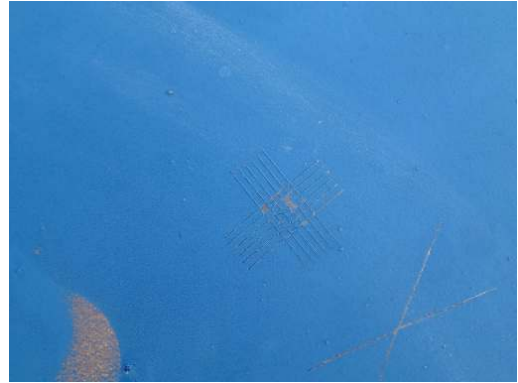
Shows adhesion testing on roof surfaces indicating generally fair interfacial adhesion

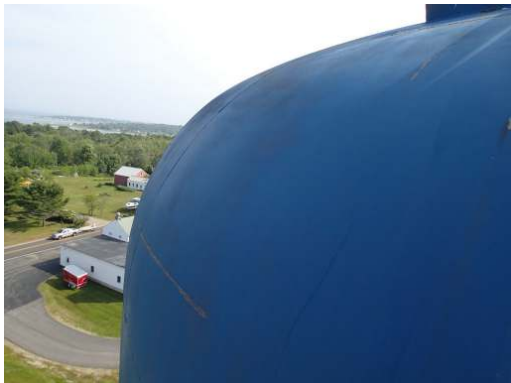
The coatings on the roof knuckle are weathered and there is evidence of abrasion damage from the revolving ladder

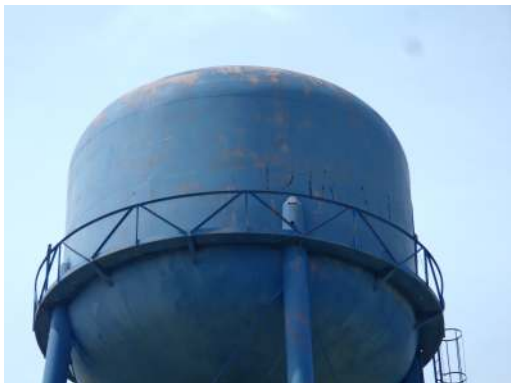
Overall view of the coatings on the roof knuckle and shell exhibiting significant weathering and areas of light rust

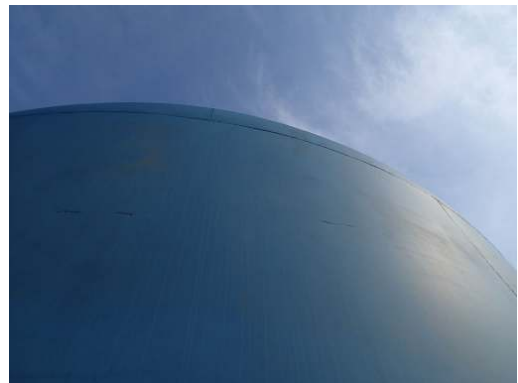
There are no open or unsealed penetrations in the shell plates to affect the sanitary condition of the tank

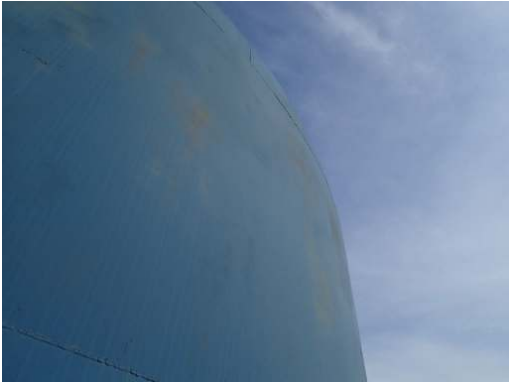
Shows light rust and soiling present on the shell plates

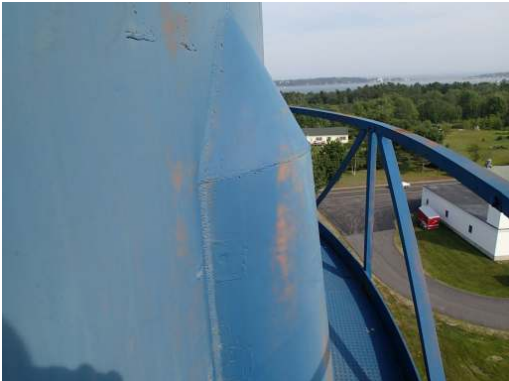
Showing top coat weathering on the shell and leg column post heads

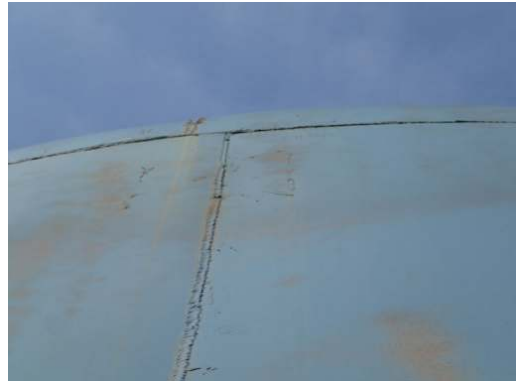
Shows what appears to be erection burrs adjacent to the shell plate weld seams

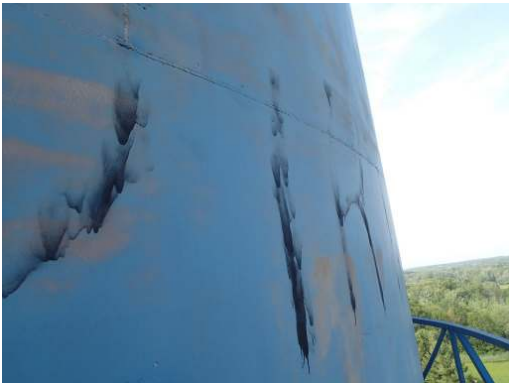
Showing graffiti on the exterior shell.

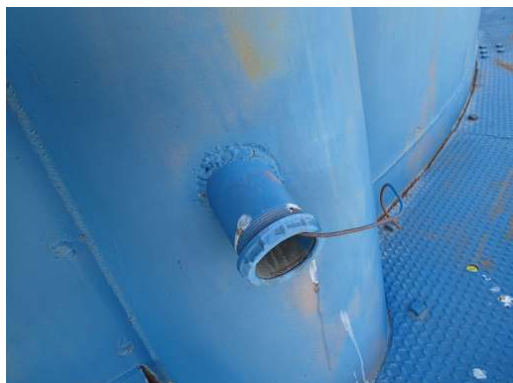
Showing wiring protruding from a pipe stub in the leg column post head at the balcony level

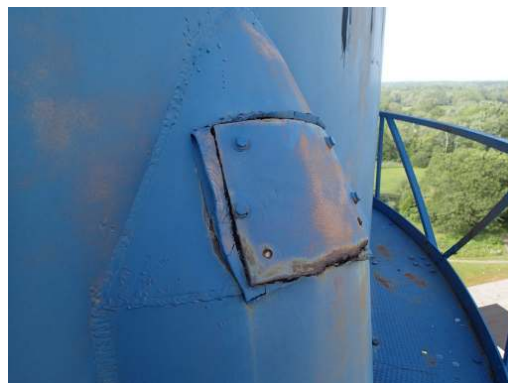
Showing corrosion on a cover plate installed to one of the leg column post heads

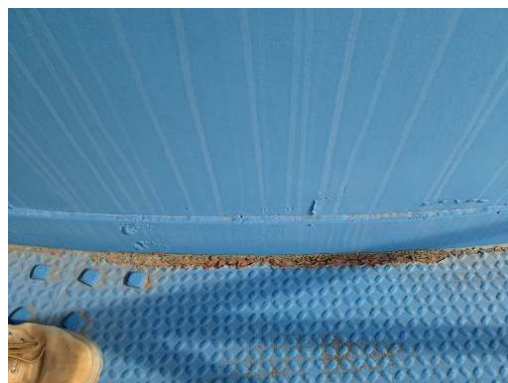
Showing heavy corrosion with possible metal loss at the shell to balcony junction

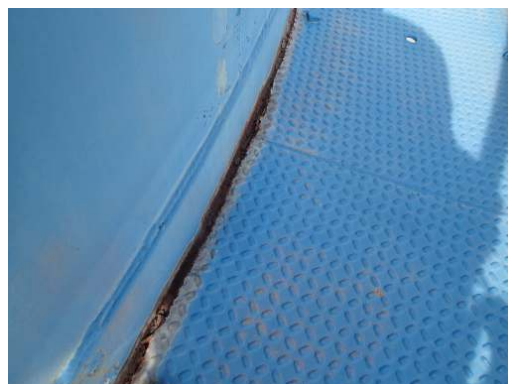
There is heavy corrosion and slight to moderate metal loss at the balcony to shell angle junction

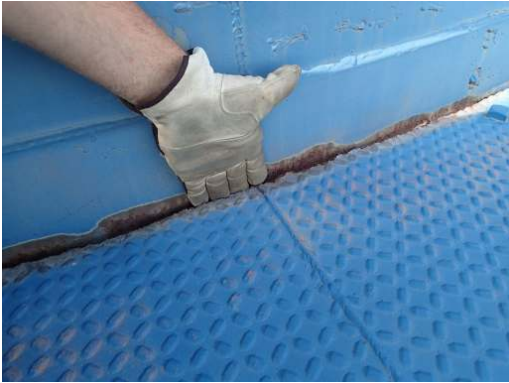
Showing a gap at the shell to balcony junction with heavy rust on the shell plate

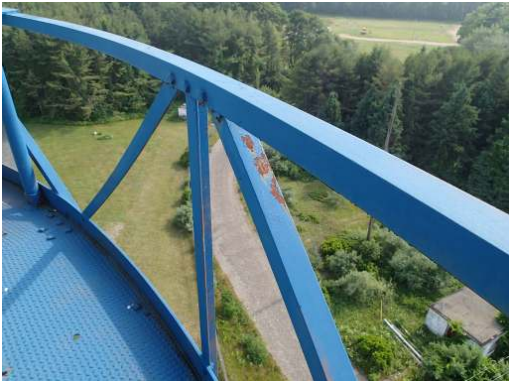
Shows scattered areas of coating failure and corrosion on the handrails.

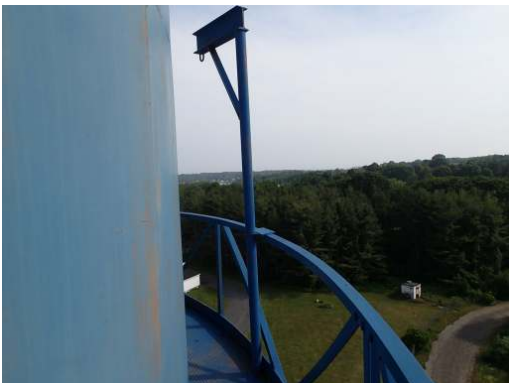
Shows a davit assembly secured to the balcony handrail

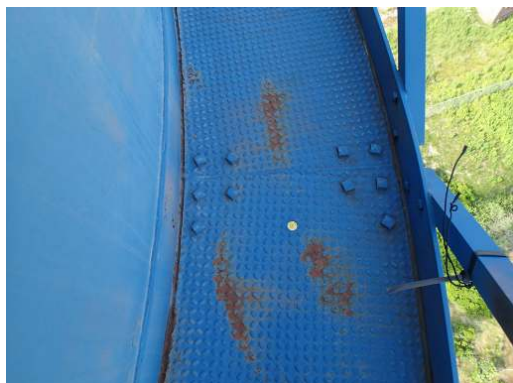
Shows an area of significant light to medium grade rust on the balcony walkway

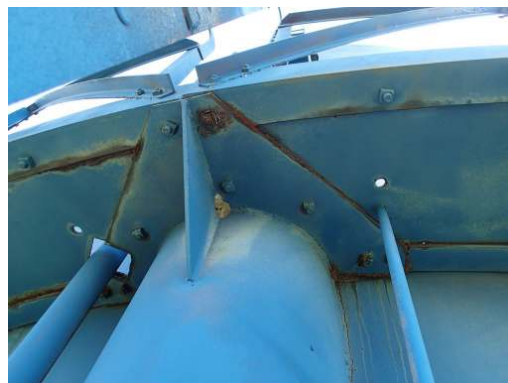
Showing corrosion along the bolts and edges where a leg column attaches to the balcony.

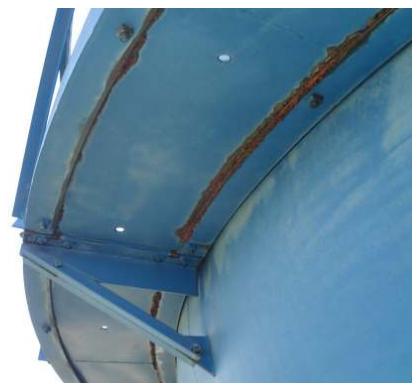
Showing corrosion and at least slight to moderate metal loss along the underside of the balcony.

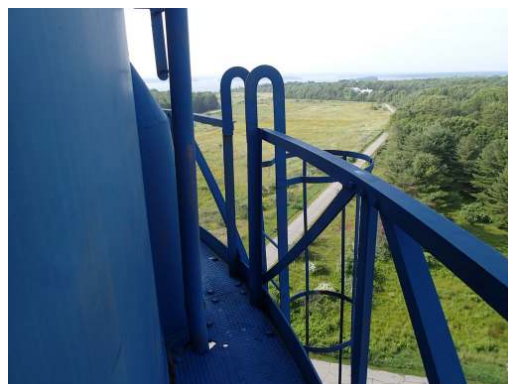
Shows a pass through in the balcony handrail which allows for access onto the balcony

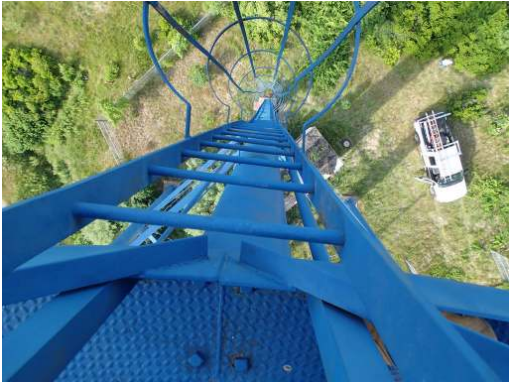
The leg column access ladder appears in sound structural condition with no obvious deficiencies observed

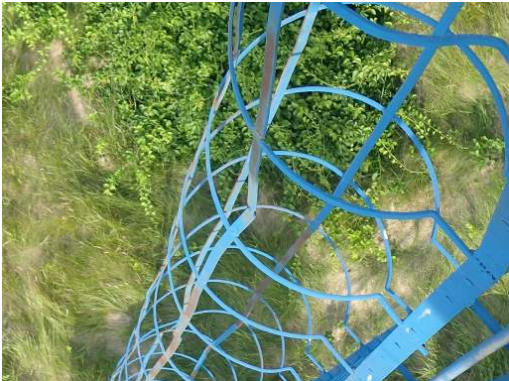
Several of the vertical ribs of the ladder cage are bent which has compromised the welds at several locations

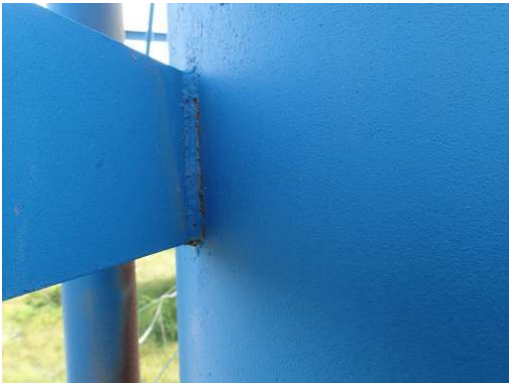
Light rust on the weld seams of several ladder to leg column brackets does not appear to be affecting the structural integrity

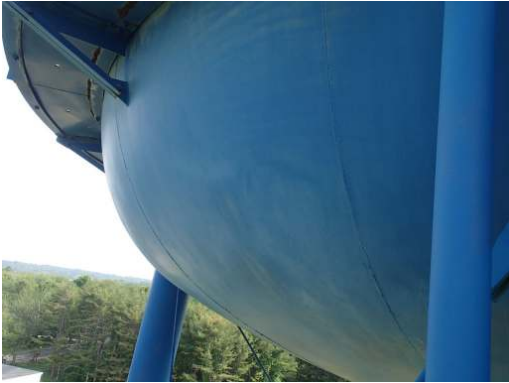
The bowl surfaces visible from the access ladder are weathered but exhibit little corrosion

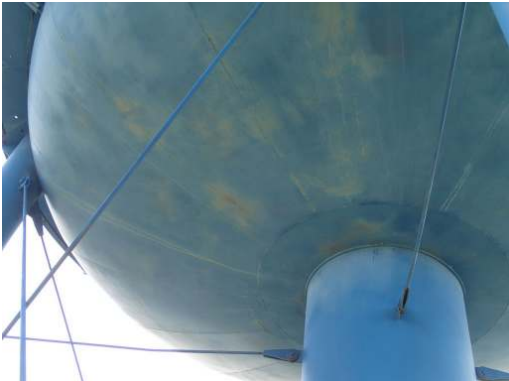
Shows significant weathered coating and scattered areas of light rust on the bowl surfaces

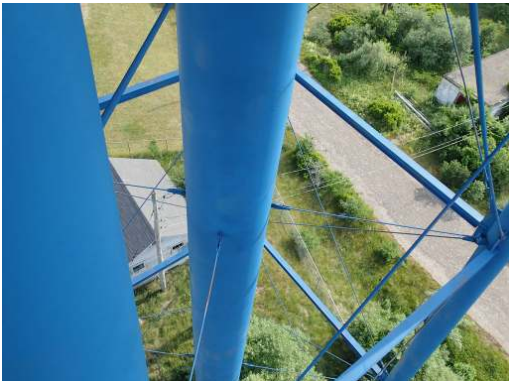
Shows an overall view of the riser and associated radial rods

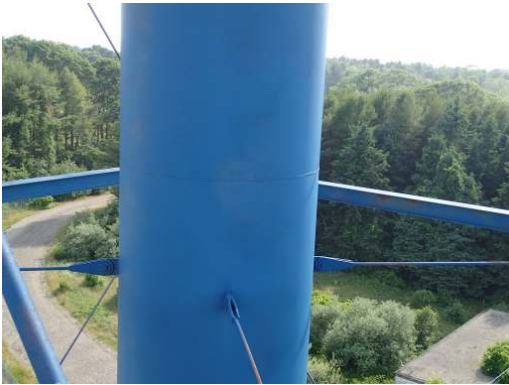
Shows areas of weathered coating on the riser

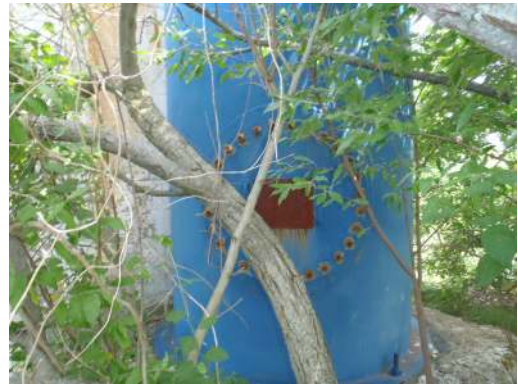
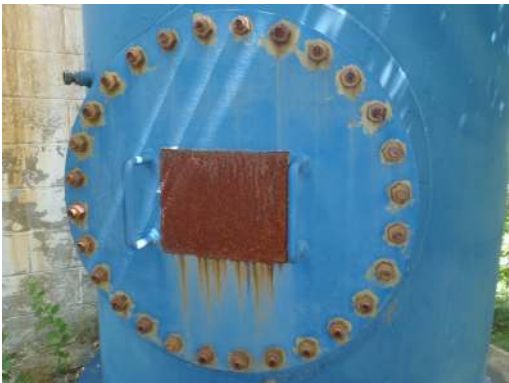
Corrosion is present on all bolted connections as well as where the tank ID plate was originally attached

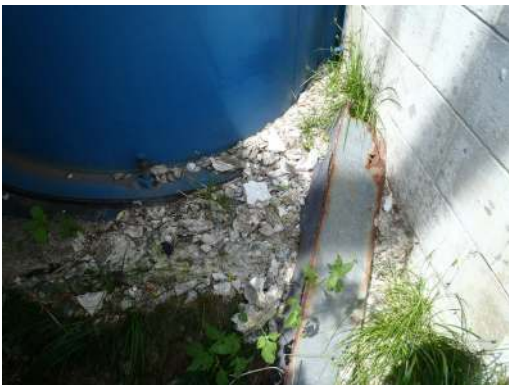
Shows the base of the riser adjacent to a concrete block building

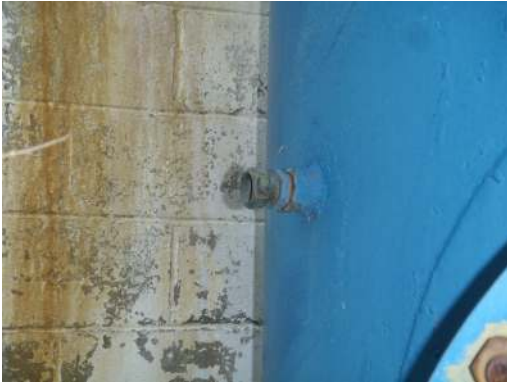
There is an unused penetration in the side of the riser adjacent to the hatch

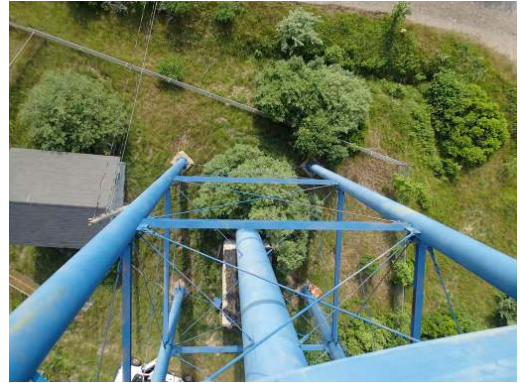
The coatings on the leg columns are weathered but exhibit little corrosion

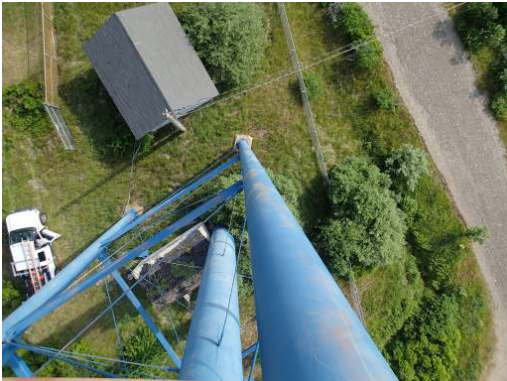
Shows significant weathering on the leg columns

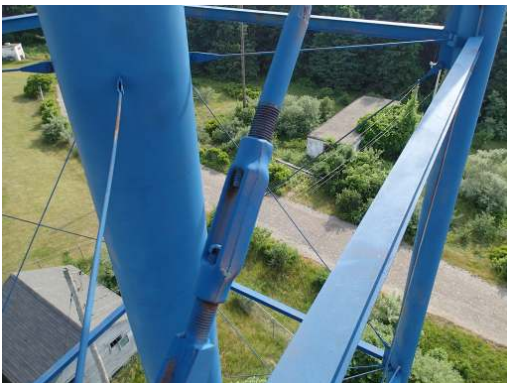
The sway rod turnbuckles are experiencing light rust but appear in good structural condition.

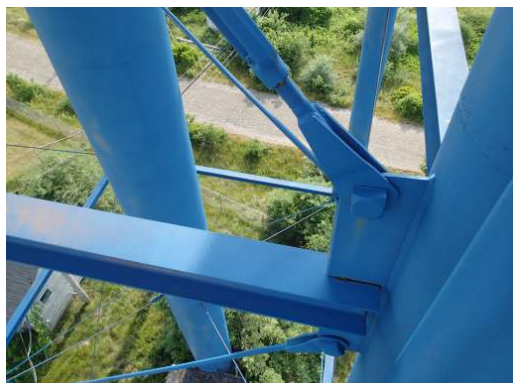
Showing localized areas of light rust on various connections to the support structure

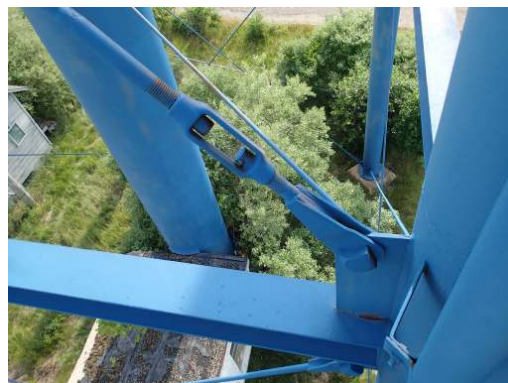
The sway rod connections appear structurally sound but are exhibiting light rust on the threads

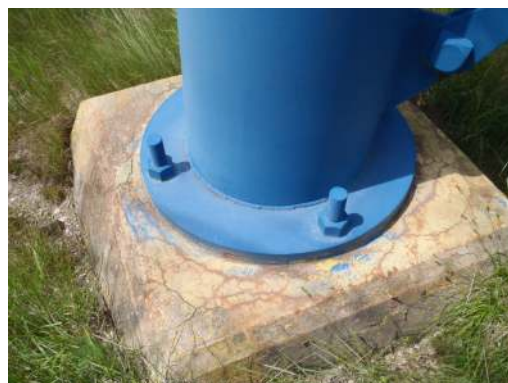
The leg column base plates appear in sound structural condition with no significant coating degradation observed

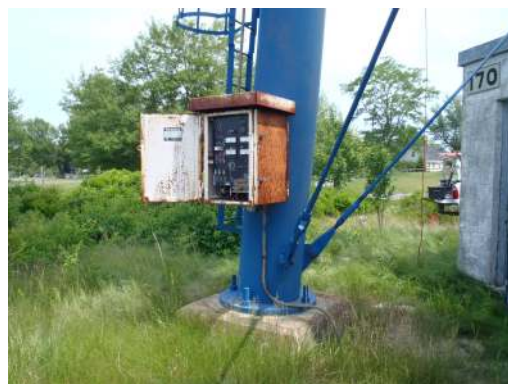
Shows an old cathodic protection control center attached to the base of the leg column

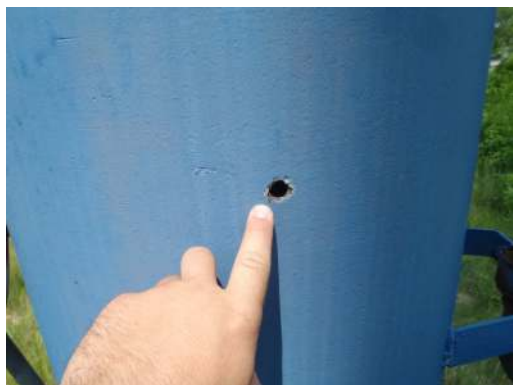
There is an ~3/4"Ø hole in the base of the leg column that supports the overflow pipe

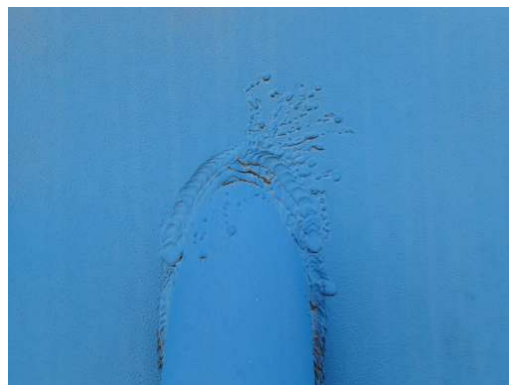
Showing rough weld and spatter where the overflow pipe attaches to the shell.

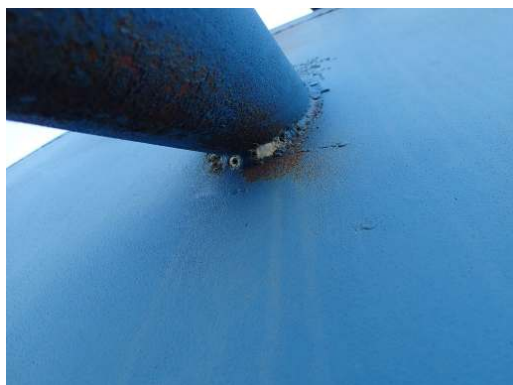
Showing corrosion on the underside of the overflow pipe and adjacent shell surfaces.

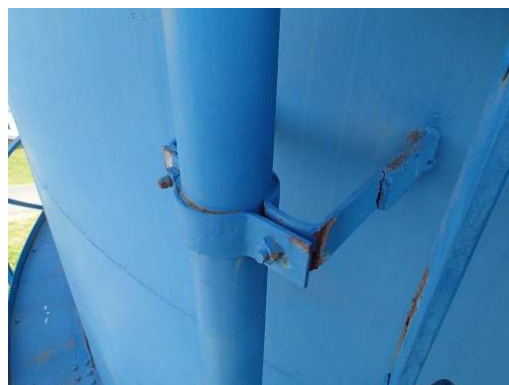
The coatings on the overflow pipe bracket above the balcony is in poor condition and there is evidence of a cracked weld

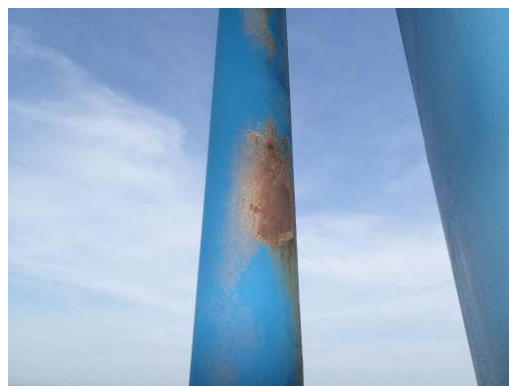
Showing corrosion on the backside of the overflow pipe as viewed from the balcony

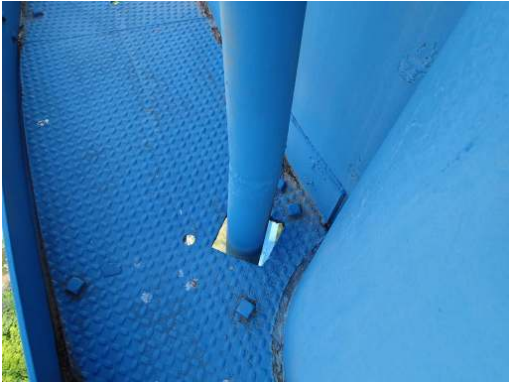
Showing where the overflow pipe penetrates the balcony.

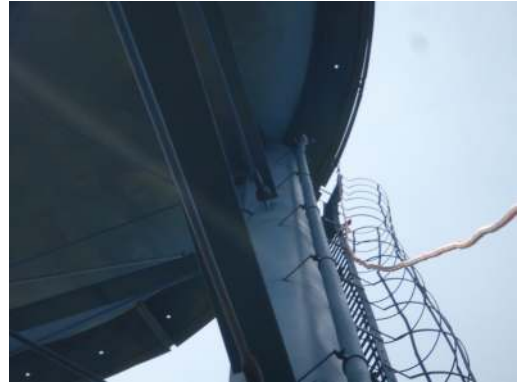
The overflow pipe is supported at multiple levels on the leg column

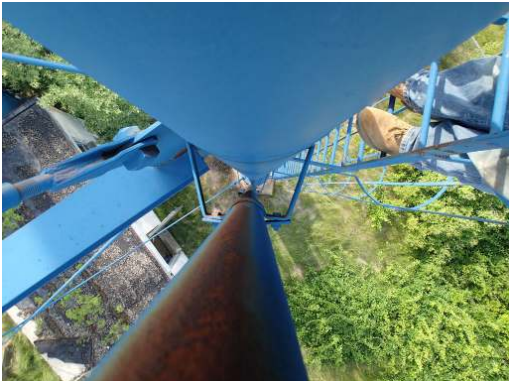
Showing corrosion occurring on the backside of the overflow pipe.

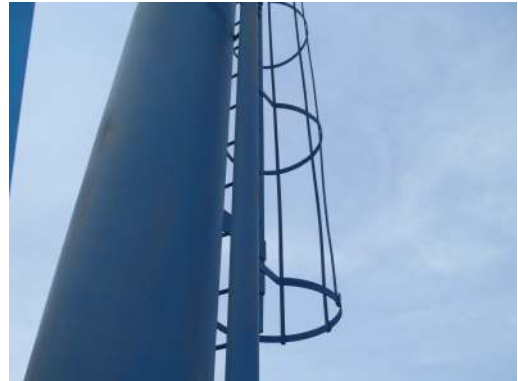
The overflow pipe coatings are in fair condition with scattered areas of corrosion mostly along the backside of the pipe

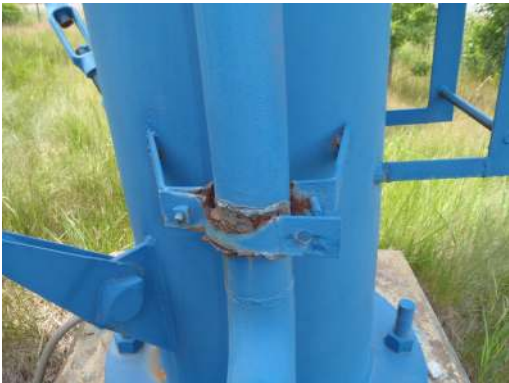
Shows heavy rust, scale and associated moderate metal loss as well as a missing nut on the lower overflow bracket

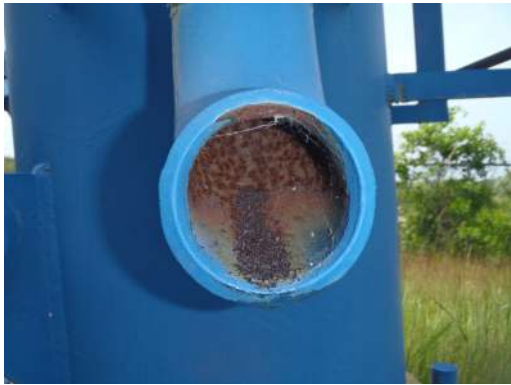
The overflow pipe is not equipped with a screen or flapper assembly

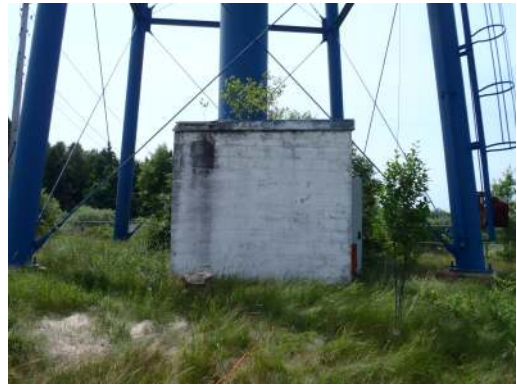
Shows a concrete block wall building under the tank and adjacent to the riser pipe

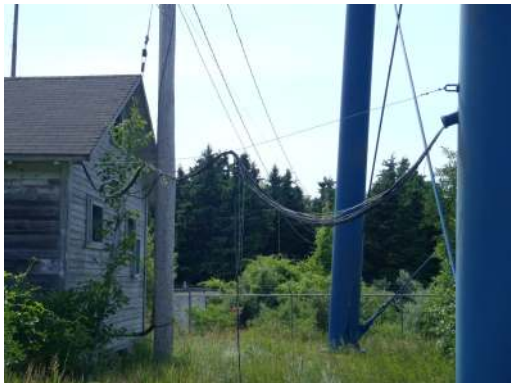
Shows wiring spanning from a wood framed building to an adjacent leg column

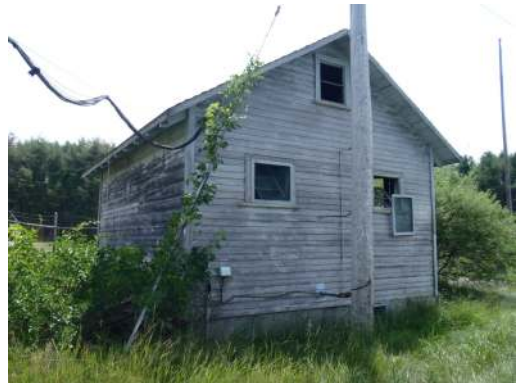
Shows a wood building adjacent to the tank

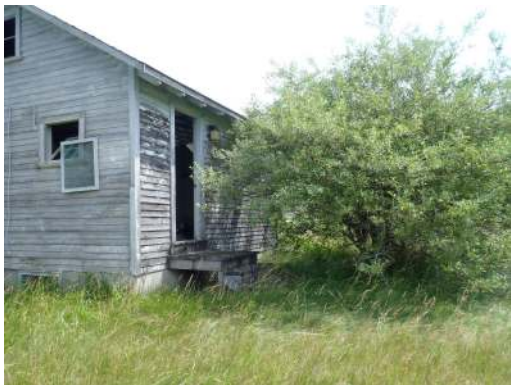
The building appears to be run down and no longer in use and there is significant vegetation growth nearby

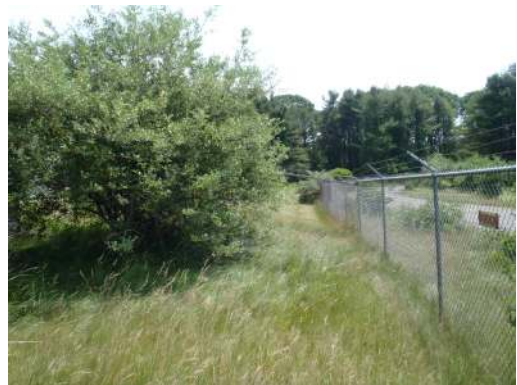
The perimeter fence surrounding the tank site appears in sound condition

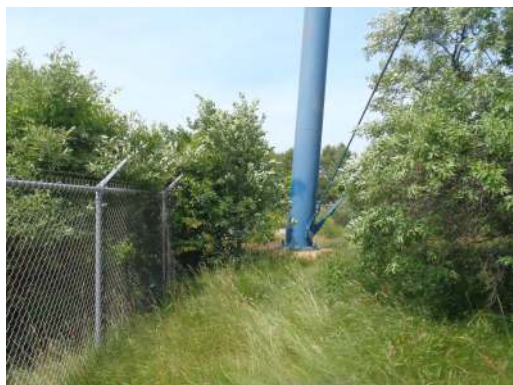
There is a heavy growth of trees/shrubs and grass both inside and outside of the perimeter fence

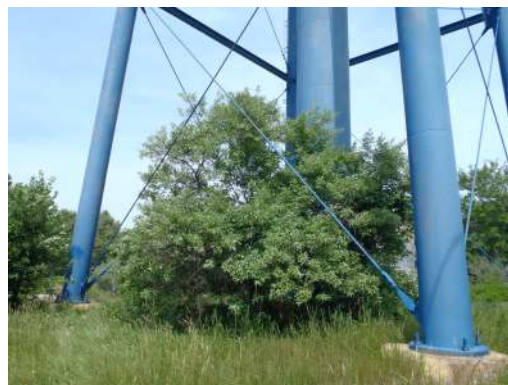
Shows large tree/shrub present under the tank

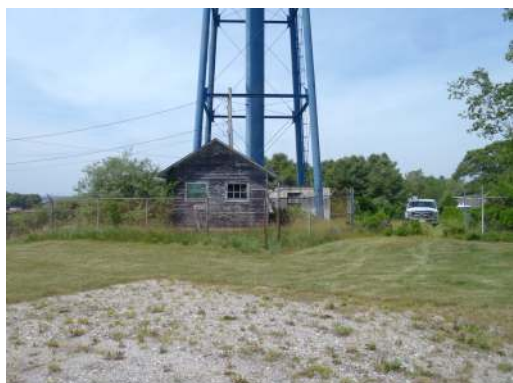
Shows the perimeter fence and access gate surrounding the tank site

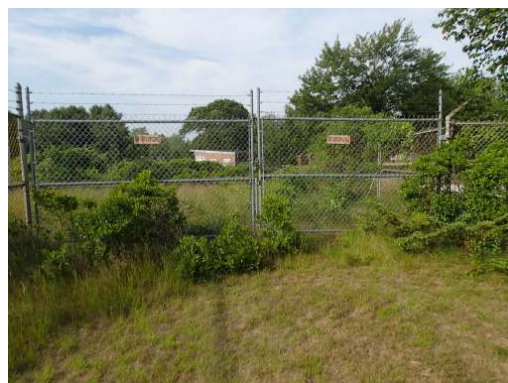
View of the closed access gate upon completion of the inspection

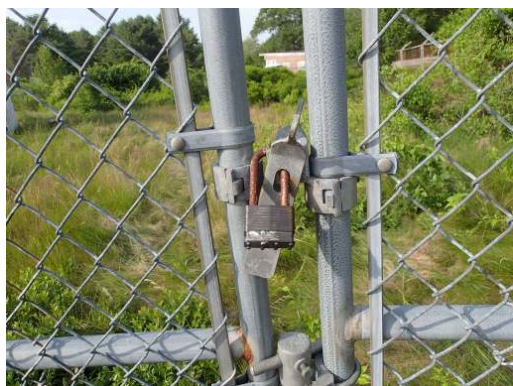
The access gate is equipped with a lock.

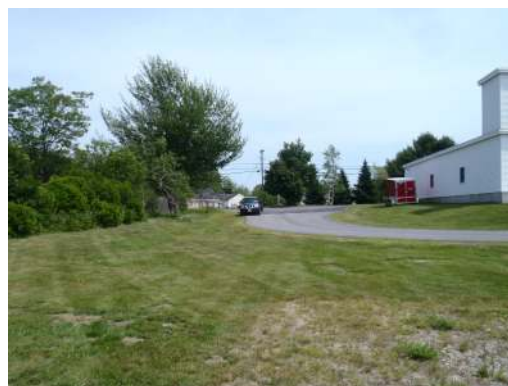
Shows the close proximity of an access road and building to the tank

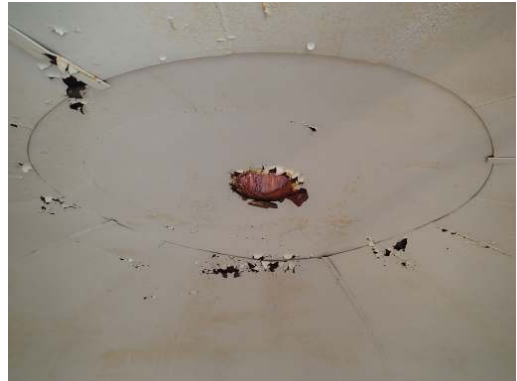
Interior roof coatings are in only fair to poor condition with areas of complete delamination to the substrate and associated medium to heavy rust as well as scattered areas

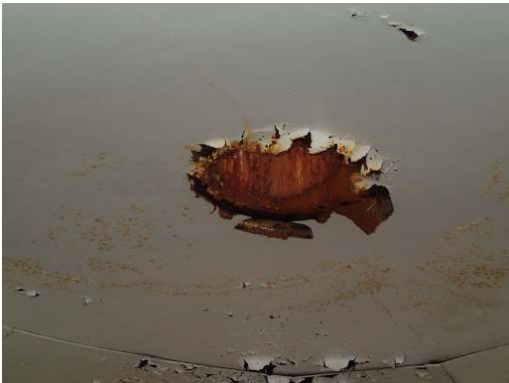
Delamination was noted along the center roof as seen near the vent opening.

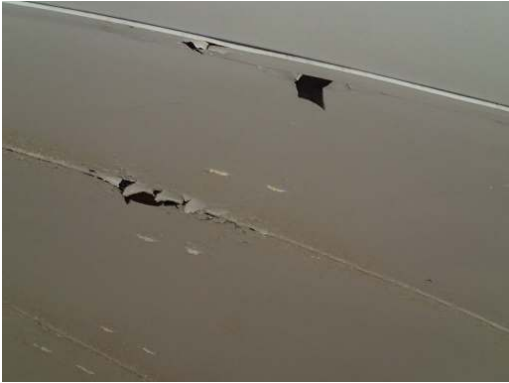
Showing delamination and corrosion along the roof plates and seams.

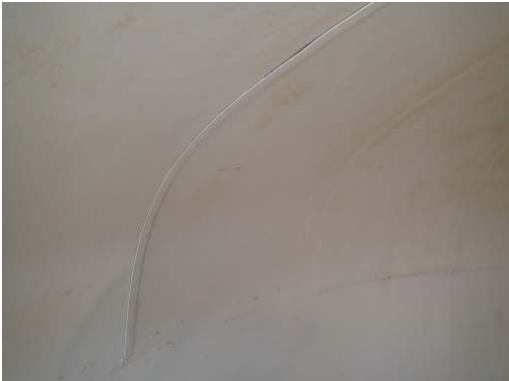
Shows backing strip in place on the underside of the roof and knuckle plates

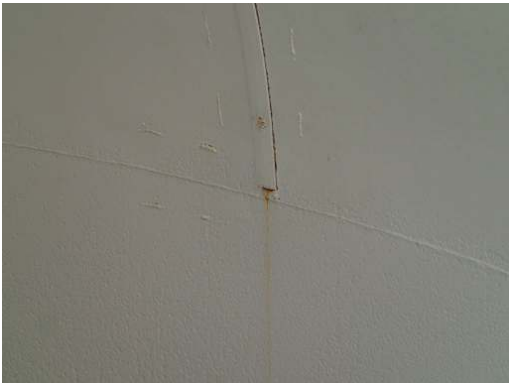
Shows corrosion under the backing straps along the roof and knuckle plates

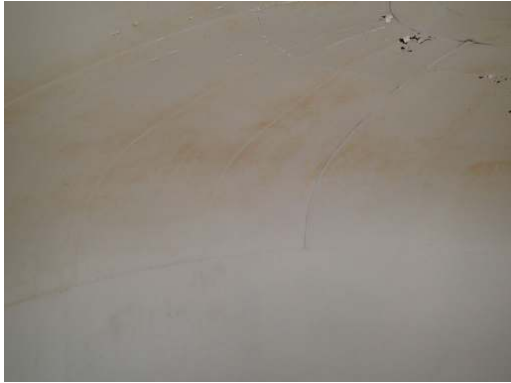
The roof appears in sound condition with no metal loss or open penetrations noted.

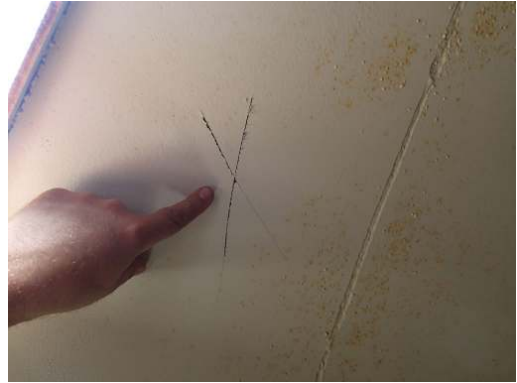
Showing an adhesion test performed on the underside of the roof indicating generally good adhesion

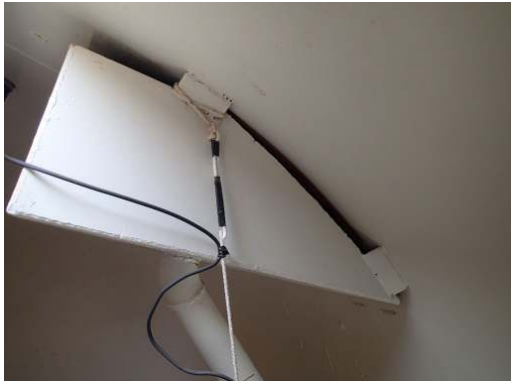
Sideview of the weir box configuration showing the box is stepped off of the roof and supported by gusset plates only with no access for painting

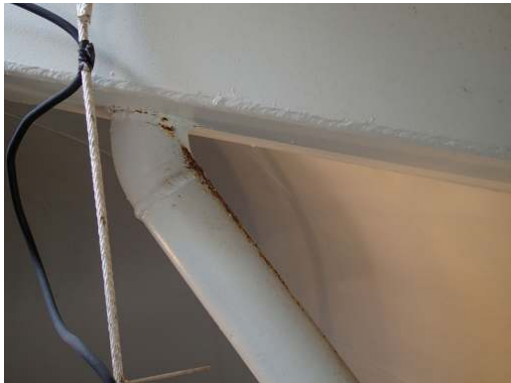
Corrosion is occurring on the internal portion of the overflow pipe.

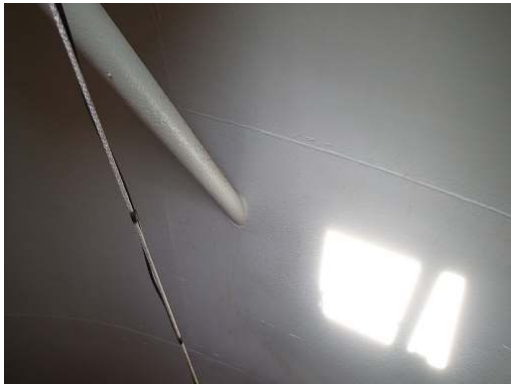
The shell coatings are in good condition and past pitting appears to be well sealed by the coating

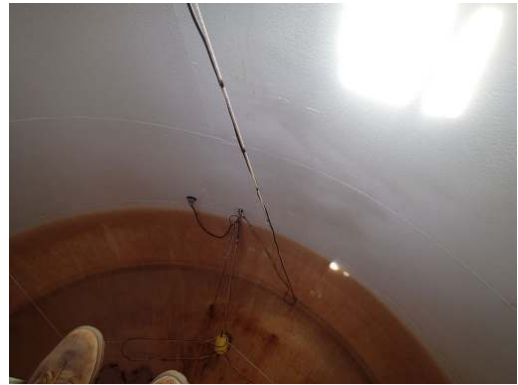
Shows past pitting on the upper shell ring which is being afforded good protection by the existing coating system

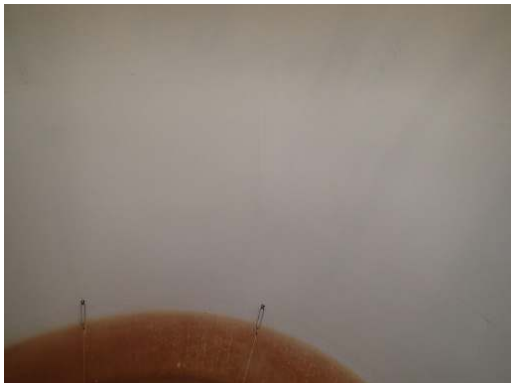
Shows no significant coating degradation occurring on the interior shell

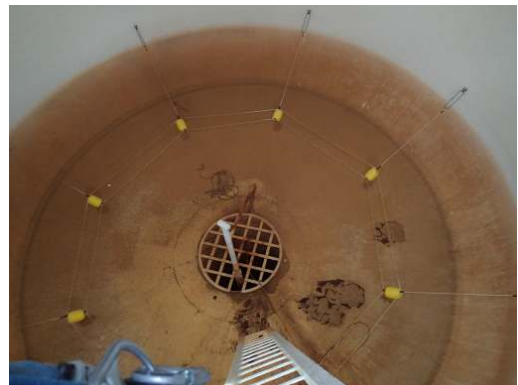
The interior bowl is stained and there appears to be three separate areas of degradation. The cathodic protection system appears intact.

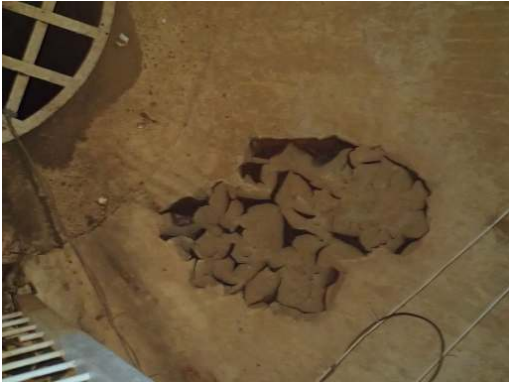
Showing an area of coating delamination and corrosion on the interior bowl.

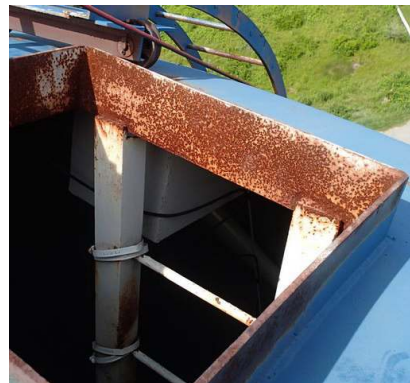
The weld integrity at the top of the interior ladder is questionable and should be reinforced

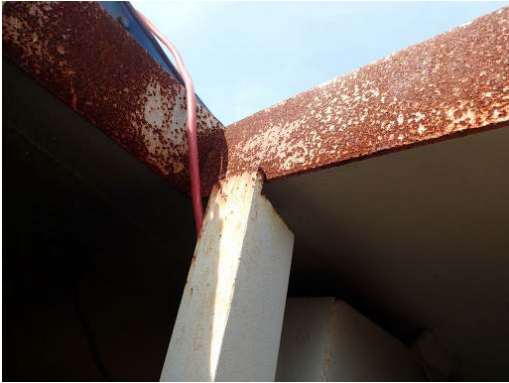
The interior ladder siderails connections to the manhole neck should be extended and reinforced during future maintenance

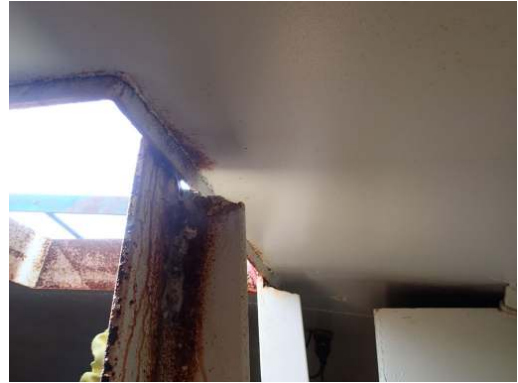
Showing corrosion on the backside of the interior ladder siderails adjacent to the roof.

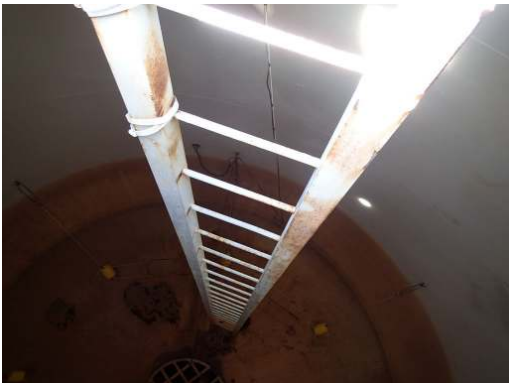
The interior ladder appears in sound structural sound condition but there is significant corrosion along the rungs and rails. There are no mid point stabilizers.

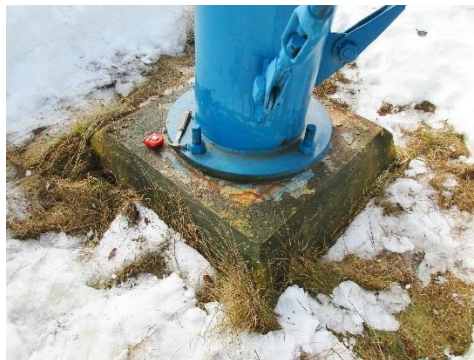
Photo 3 – SE Foundation Pier

1. Column Leg Pier Foundations: The concrete piers were found to be in fair to poor condition. Each pier had varying degrees of surface defects on the top and exposed sides of the pier, including spider cracking (or “crazing”), hollow concrete, spalling, and evidence of moisture penetration through surface cracks (white staining or “efflorescence”). Approximate estimates of the percentages of hollow concrete for each pier are as follows: Southwest (SW) Pier – 75%; SE Pier – 50%; NW Pier – 25%; NE Pier – 50%. Minor spalling was observed on the corners of the SW & NE piers. Conditions of below-grade portions are unknown. It appears that the concrete was originally coated, but only small portions of the blue coating are still intact. The painted steel column legs and anchor bolts are in fair condition with no major signs of corrosion or structural weakness; the paint is worn and faded, but the lower portions exhibit only minor levels of surface corrosion.

2. Column Leg Pier Foundations: The extensive cracking in these foundations makes them susceptible to future moisture penetration and damage, with some evidence that this has already been occurring for many years to varying degrees. All areas that are cracked, hollow, spalled, or otherwise unsound shall be chipped down to a depth as required to achieve a sound, durable concrete substrate. It is anticipated that the perimeter of the piers should be dug down approximately 12" to expose the foundation and inspect condition. Once the unsound areas are delineated, the perimeter of all repair areas shall be saw-cut to a depth of 1". All areas inside each repair area shall be chipped out to a uniform depth of no less than 1", but deeper for areas where necessary to find sound concrete. If reinforcing is encountered during demolition, it will be inspected, cleaned, and coated with an anti-corrosion bonding agent. Any repair areas deeper than 2" shall be reinforced with nominal steel reinforcing (#4 @ 12" on center) to mechanically bond new concrete to existing concrete. Sides shall be formed with plywood to match existing pier wall geometry, including the edge chamfers. Epoxy bonding compound should be applied to all existing concrete substrates to enhance bond. New high-performance repair mortar shall be installed to restore lost concrete as required to match the pier's original geometry. After proper curing is complete (minimum of 7 days), it is recommended that all exposed-to-view concrete be coated with an elastomeric polyurethane coating to provide added moisture protection to the concrete. The painted steel superstructure should be prepared and repainted in the next 3-5 years.
